InstaShiatsu+ Massage Chair MC-1000

MC-1000 Air Bag Troubleshooting

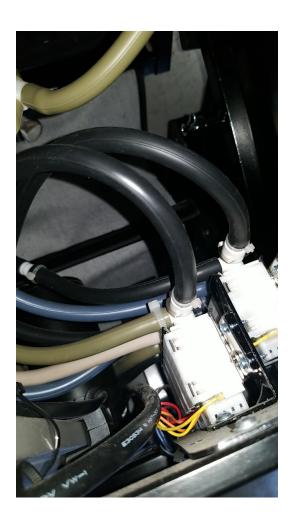
1. Ensure hoses are properly connected:

- Check the underside of the chair to locate the hoses.
- Examine the connections to ensure they are securely fastened.
- Make sure there are no kinks or blockages in the hoses that could impede proper airflow.

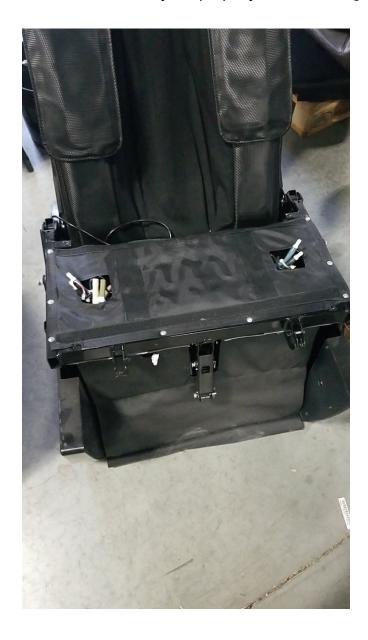
2. Remove the seat cushion to check the connections:

- Locate the seat cushion attachment points on the chair.
- Carefully remove the seat cushion to access the connections underneath.
- Inspect the connections to ensure they are properly seated and tightened.
