## InstaShiatsu+ Massage Chair MC-2000

### Massage Head Distribution Valve Replacement

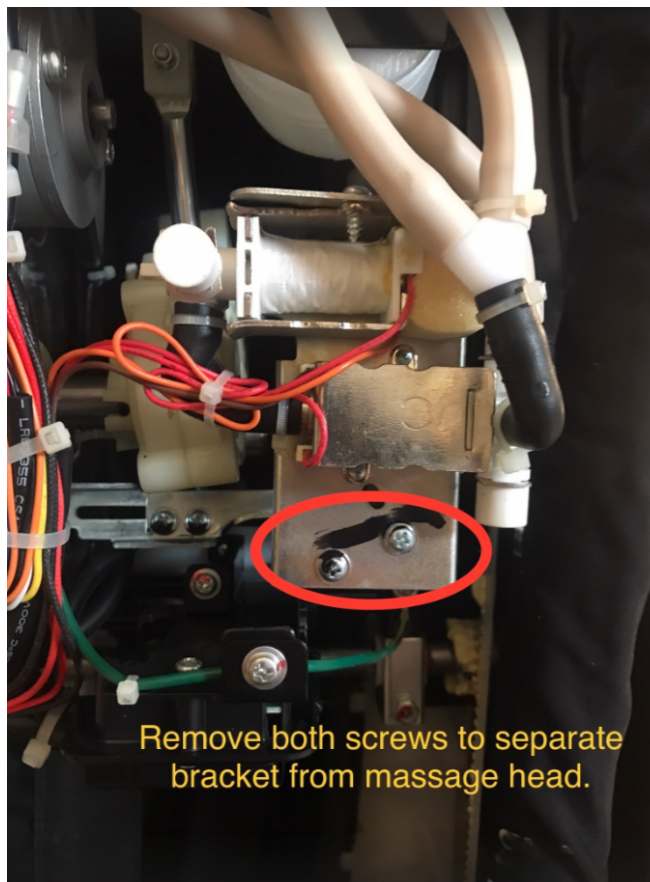
1. Gather the necessary tools: Phillips head screwdriver and wire cutters.
2. Locate the two screws that secure the bracket to the massage head.
3. Using the Phillips head screwdriver, carefully unscrew and remove both screws from the bracket.

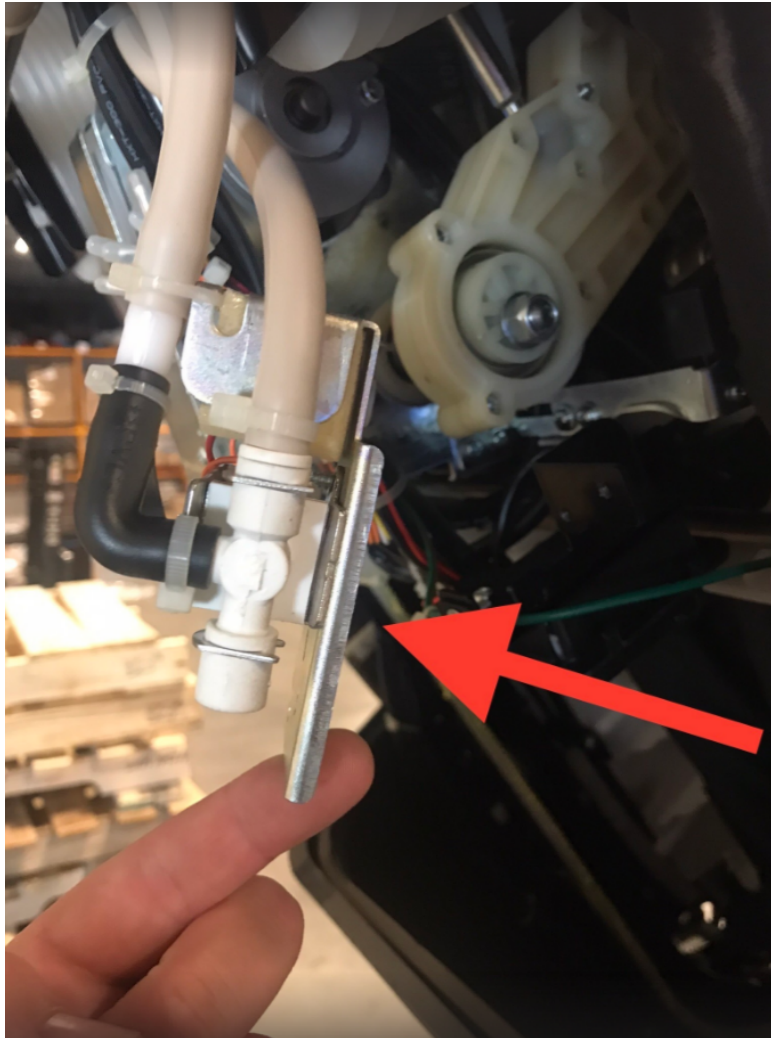
4. Once the screws are removed, gently separate the bracket from the massage head.

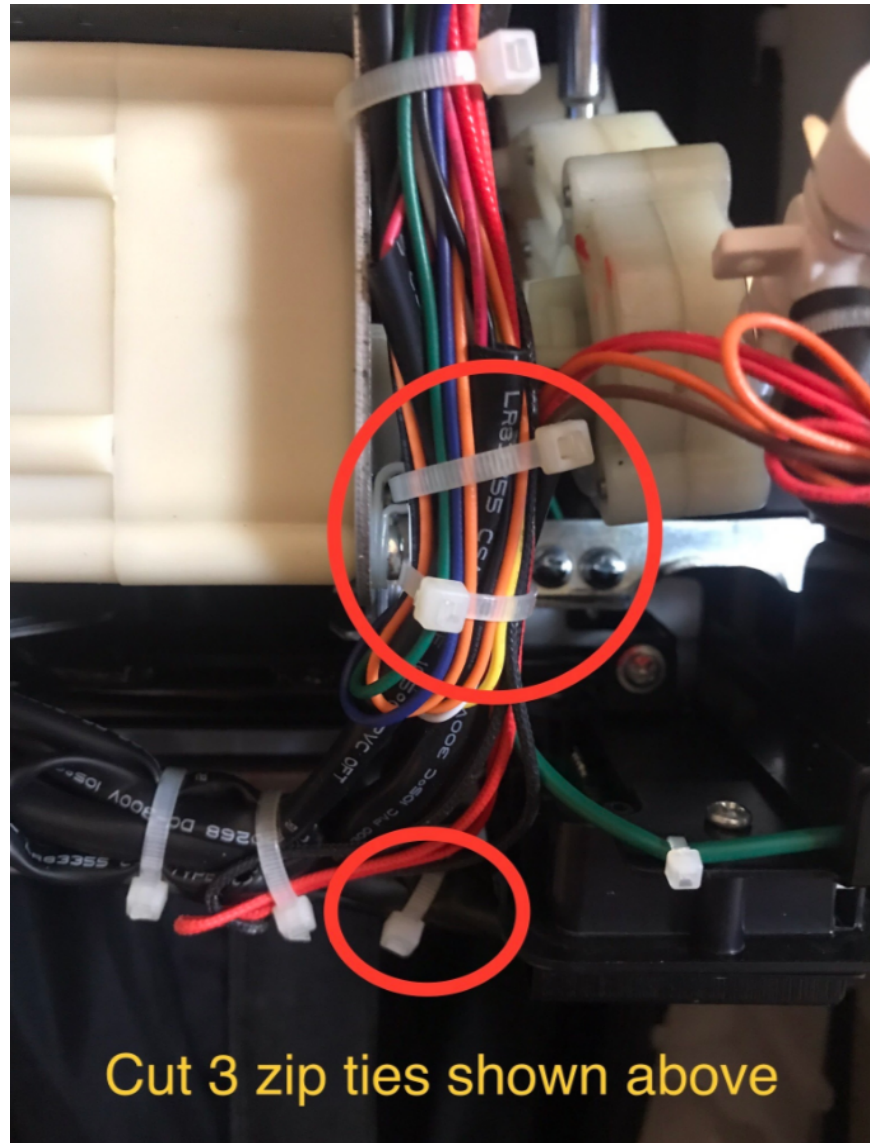
5. Identify the three zip ties that secure various components.

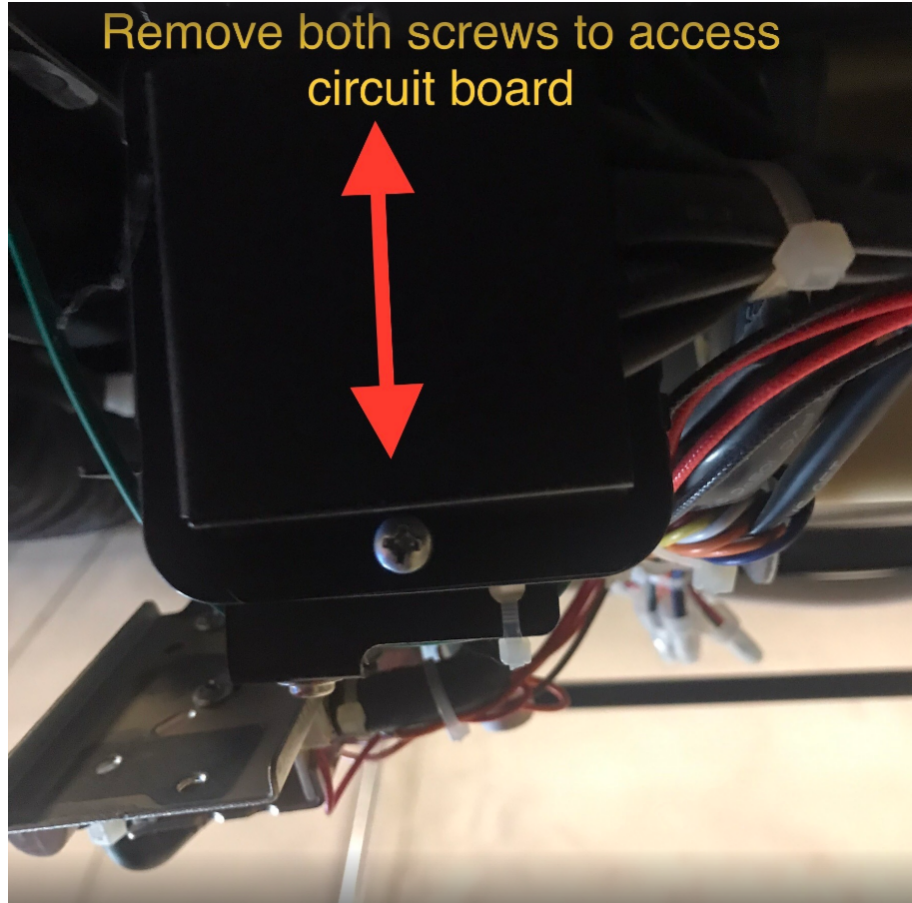
6. Using the wire cutters, carefully cut the three zip ties, one by one, to release the tension and remove them.
7. Locate the two screws that secure the circuit board in place.
8. Use the Phillips head screwdriver to unscrew and remove both screws from the circuit board.

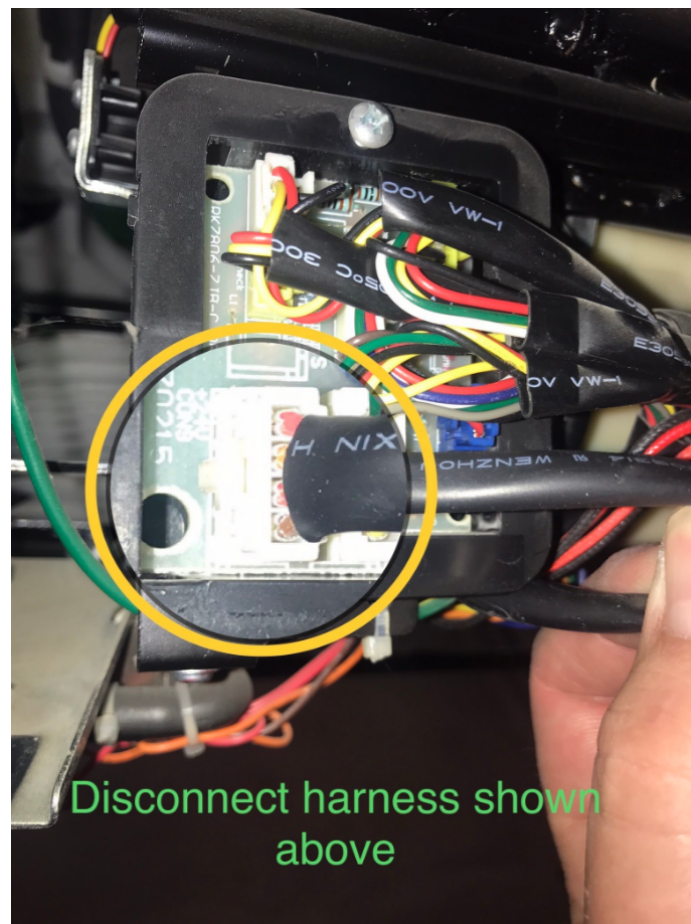
9. Once the screws are removed, carefully lift the circuit board to access the wiring harness.
10. Locate the wiring harness connected to the circuit board.
11. Gently disconnect the harness by pulling it apart. Avoid pulling on the wires directly to prevent damage.
