InstaShiatsu+ Massage Chair MC-2000

Drive Motor Replacement

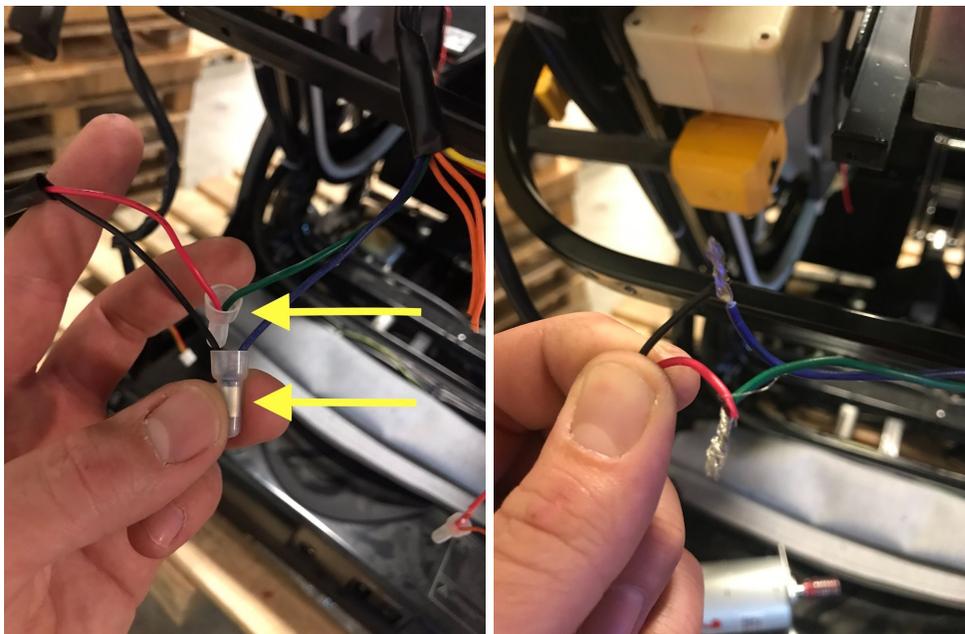
3. Remove the MC-2000 drive motor

- Identify the screws that are circled in red and holding the motor in place.
- Carefully unscrew and remove these screws using the appropriate screwdriver.
- Gently detach the MC-2000 drive motor from its current position, ensuring not to damage any other components in the process.

4. Manage the wiring

- Take note of the color wiring for future reference before proceeding.
- There are two options to handle the wiring:
 - a) Unwind the wires: Slowly unwind the wires and remove any wire connectors (marrettes) that may be present.
 - b) Cut the wires: If it's necessary to cut the wires, use wire strippers to strip the wire ends after cutting. Make sure to leave enough length for reconnection later.
